## **Proposal and Motivation for Infrastructure Upgrading at Phiri Primary School**

The intention of this report is to review the school's current state and determine the need for upgrading, especially with relevance to ablutions.

**SITE EVALUATION REPORT - ADDENDUM A**

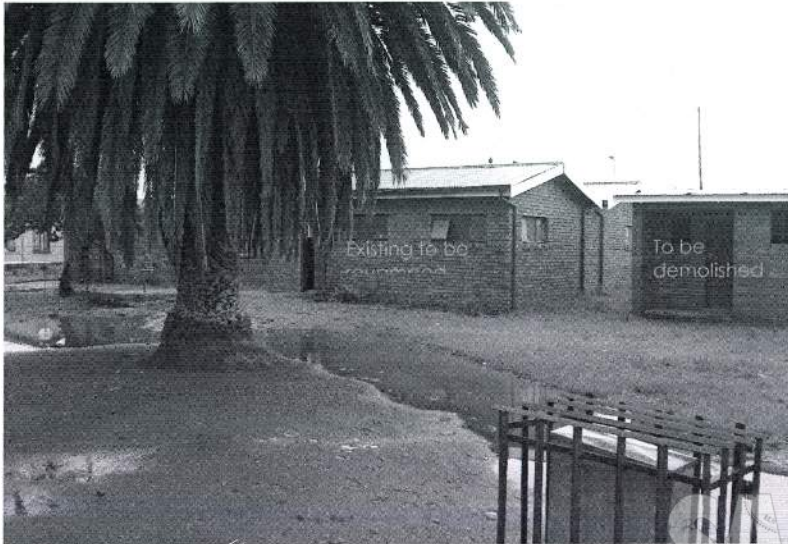
Existing to be demolished

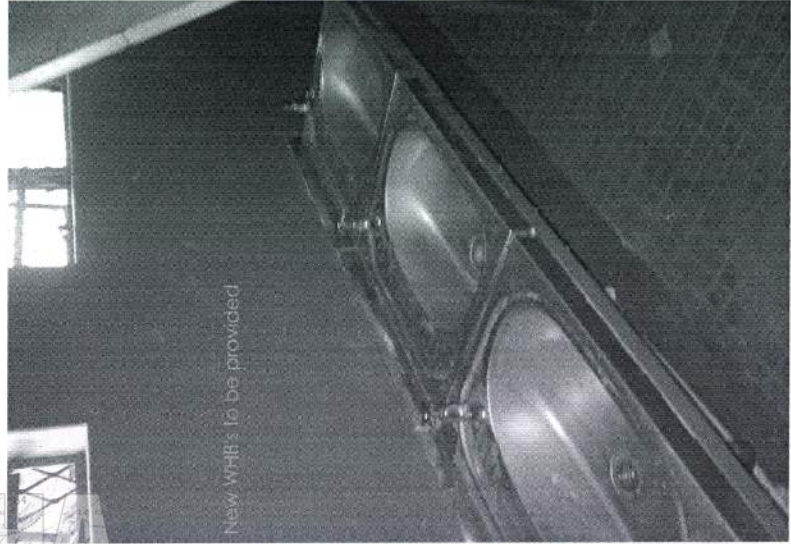
To be demolished

New WHB's to be provided

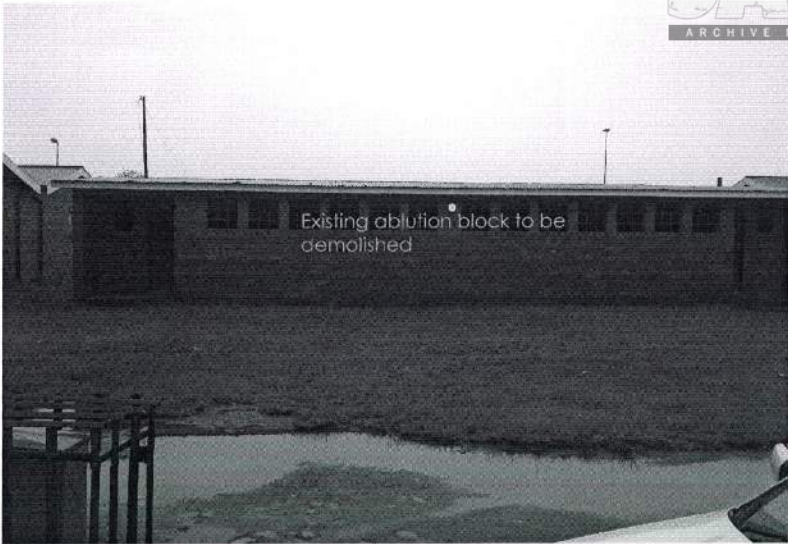
Existing ablation block to be demolished

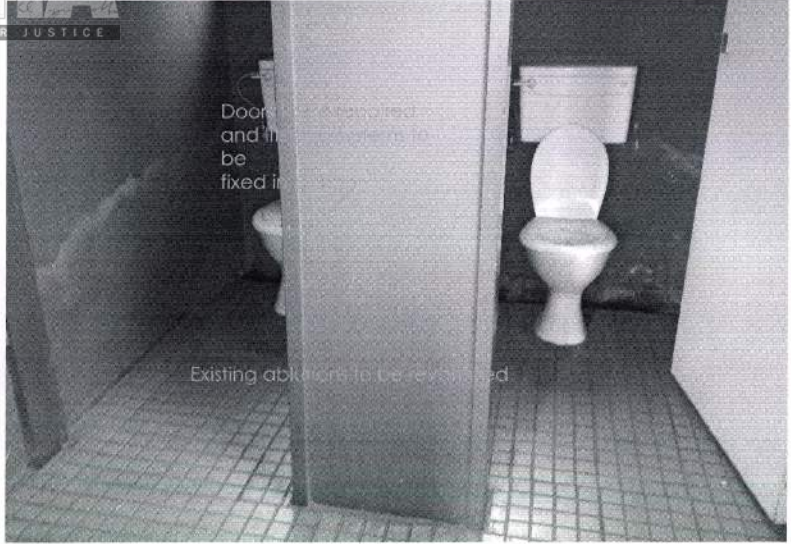
Existing ablation to be replaced

Doors to be replaced and the stalls to be fixed in

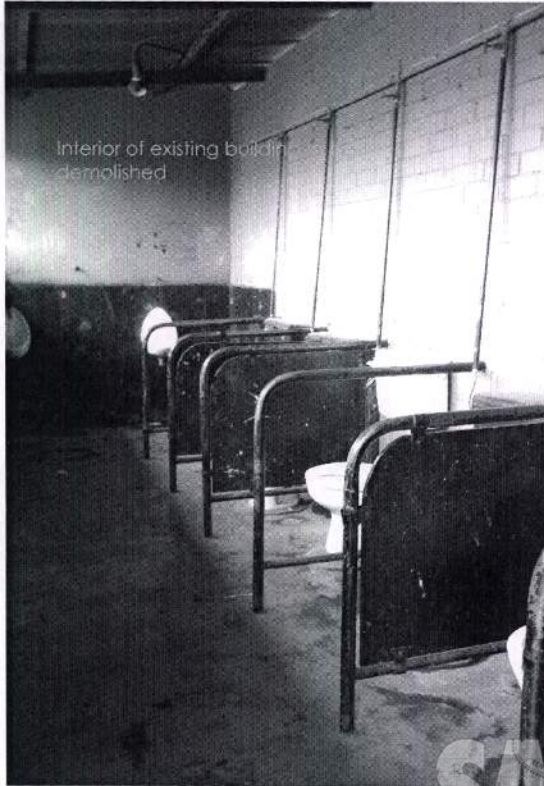
Interior of existing building demolished

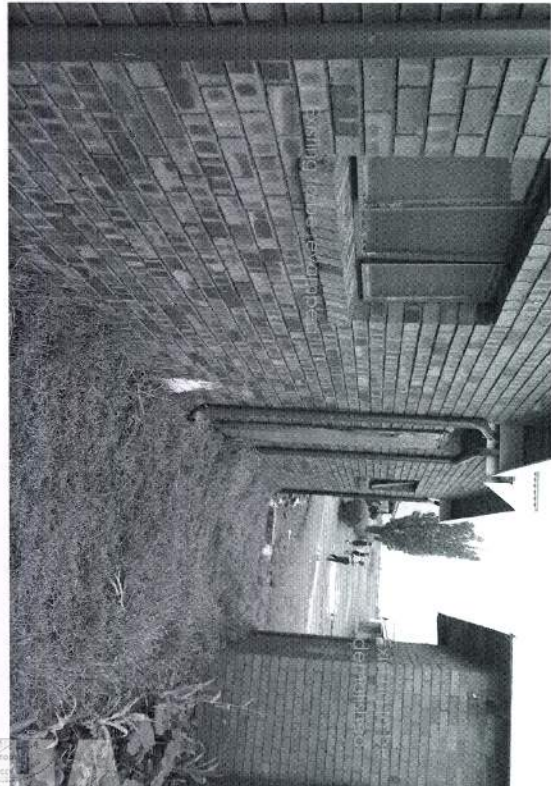
Demolition site

Existing building exterior

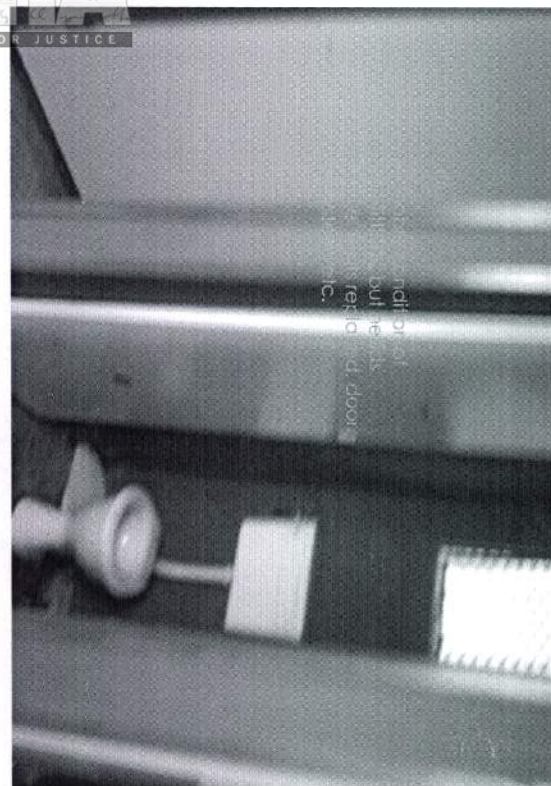
Interior view of building
