**CONTRACT C-IS 02-2007 (T)  
DOLOMITE SPECIALIST CONSULTANTS**

**WORKS ORDER NO. 37**

**MAKAUSE INFORMAL SETTLEMENT, GERMISTON NORTH  
INTERIM SINKHOLE ASSESSMENT REPORT**

**KHH 1661 / 5218**

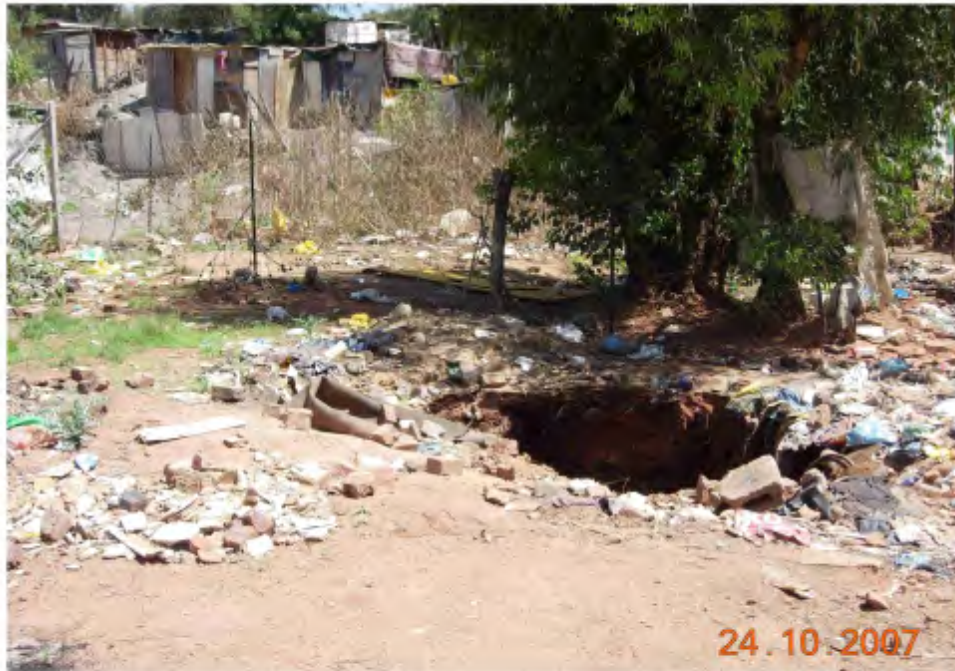
- An opening measuring approximately 4m by 2m was observed at the ground surface. The opening is an old mine shaft that has a depth of 80m according to the community leader.
- According to the community leader, a smaller opening had formed at the same position above the mine shaft approximately 3 years ago. The informal settlers then filled the hole with building rubble and rubbish. Following the heavy rainfall in early October, the opening had re-appeared on 10 October 2007 up to its present size.

**Plate 1.** Opening to the mine shaft which measures 4m x 2m.

The exposed mine shaft at the Makause Informal Settlement poses a very serious danger to the lives of the informal settlers. Despite the affected area being fenced off, there is still a real danger that children or animals could gain access to the opening at the ground surface and fall down the mine shaft inadvertently.

The Council for Geoscience (CGS) is currently appointed by the Department of Mineral and Energy Affairs (DME) to rehabilitate all open shaft areas. The position of the new opening was given through to Mr. G. Heath of CGS, who will follow up the matter with DME. It is provisionally recommended that an area of 30m radius around the opening be fenced off with a 1,8m high fence to prevent access, and a concrete cap is used to seal the mine shaft but this will have to be determined by the responsible parties.

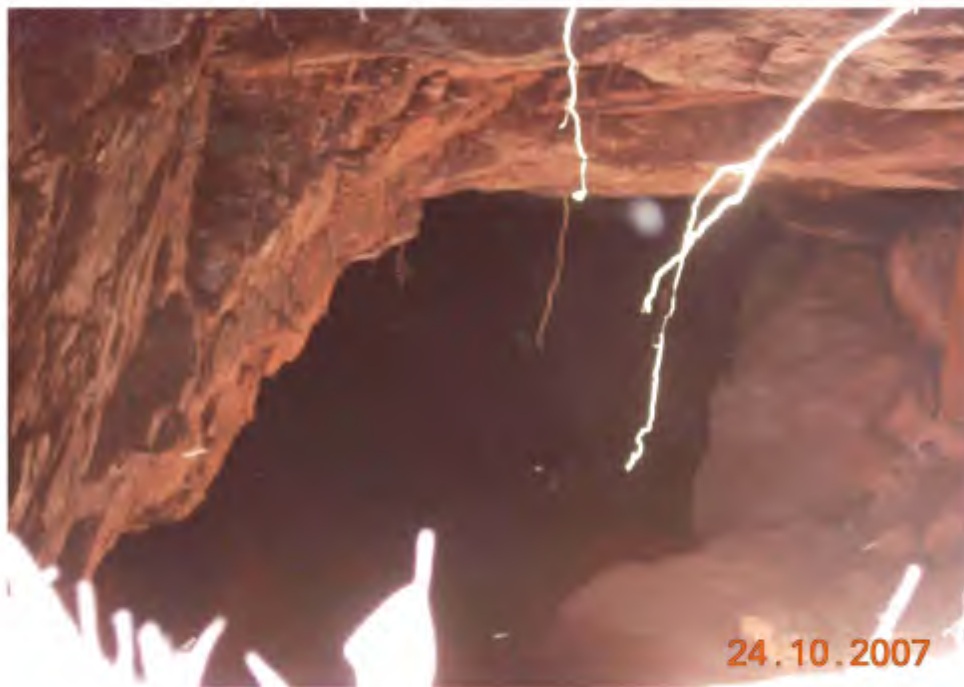
The upper 10m of the mine shaft up to the ground surface was observed to comprise residual shale and quartzite which appears to be underlain by quartzite rock.

**Plate 2.** View inside the opening to the sub-vertical mine shaft.
