**ASSESSMENT REPORT:
REMAINDER OF PORTION
132 FARM DRIEFONTEIN 87-
IR, PRIMROSE**

JOB 107

Contract PS CP 53-2013

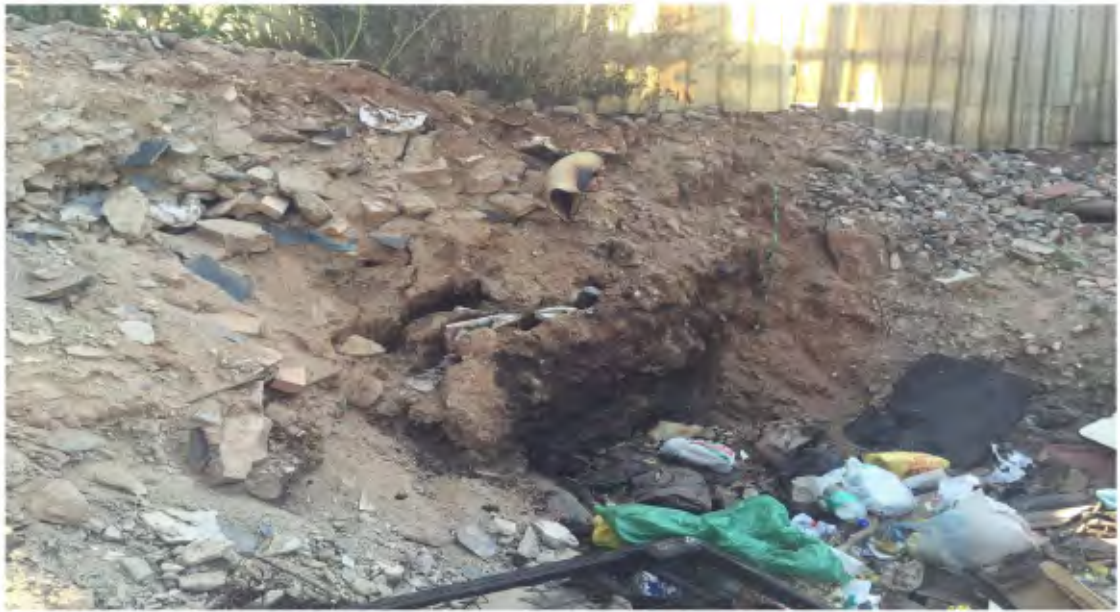
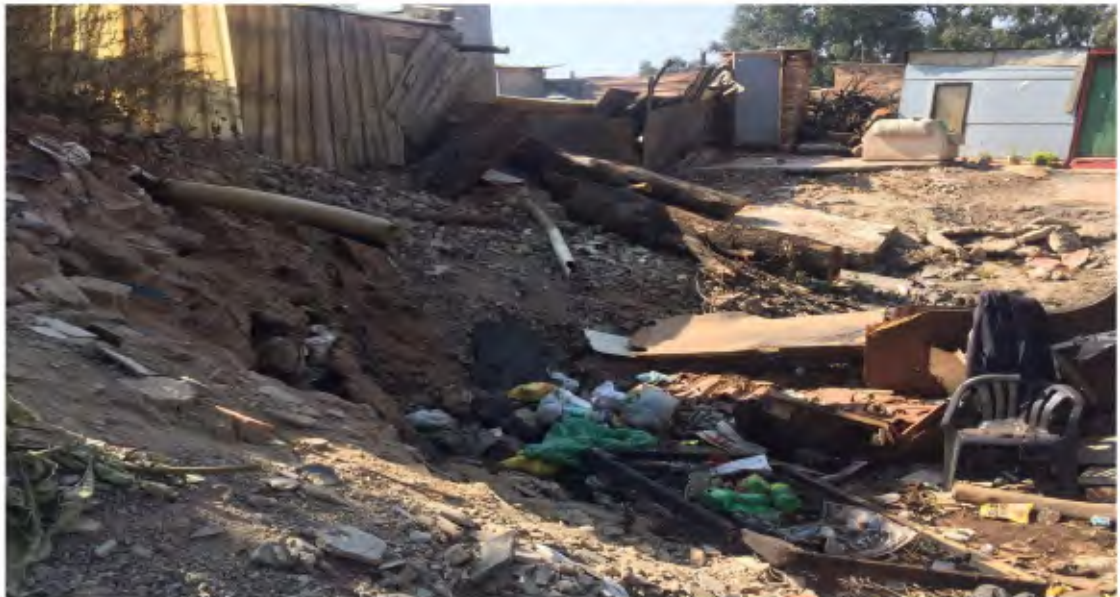
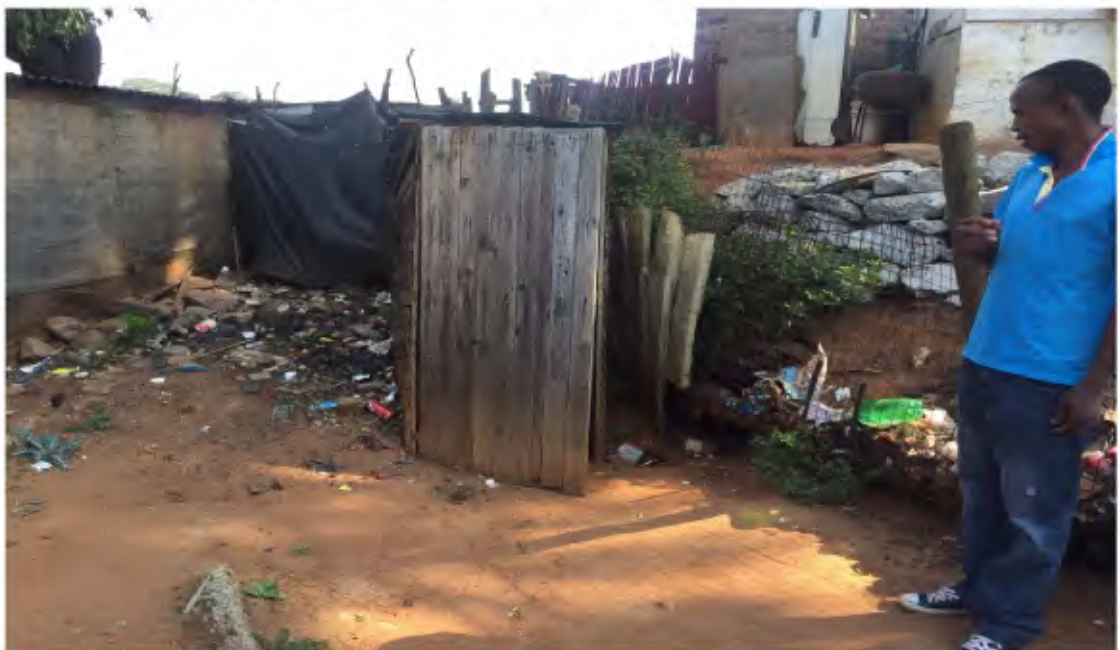
- A big subsidence occurred next to the fence where there are dumps observed.
- A pit toilet subsiding with the ground on the other side (approximately 6m away from the main subsidence) in the middle of sharks was observed.
- No Municipality wet services running along where the subsidence occurred was observed.
- No current leaking of EMM wet services were observed during investigation.

From the investigations done, the subsidence where there are dumps was observed and the pit toilet that looks subsiding down with the ground at the other side of the shacks. There are no municipal wet services running through where the subsidence occurred. According to the geological map (2628 EAST RAND), the greater area is laid on an old underground mine (not active). The subsidence could be old mine workings or rather the fill/dumping, consolidating the rubble and leaving a void. No further investigation was done as the site is on privately-owned land.

It is therefore recommended that the area affected should be cordoned off within a 10m radius, no occupation should be allowed in this area.
