NOVEMBER 2016

**ASSESSMENT REPORT ON REMAINDER OF PORTION 132 FARM
DRIEFONTEIN 87-IR (PRIMROSE)**

JOB 150

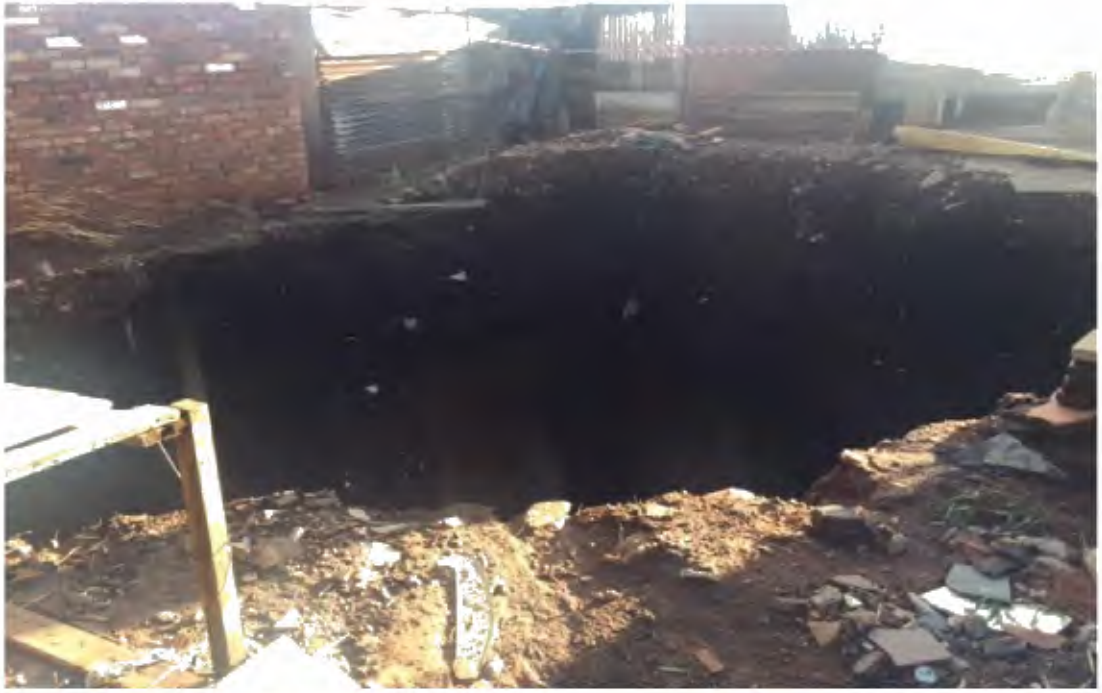
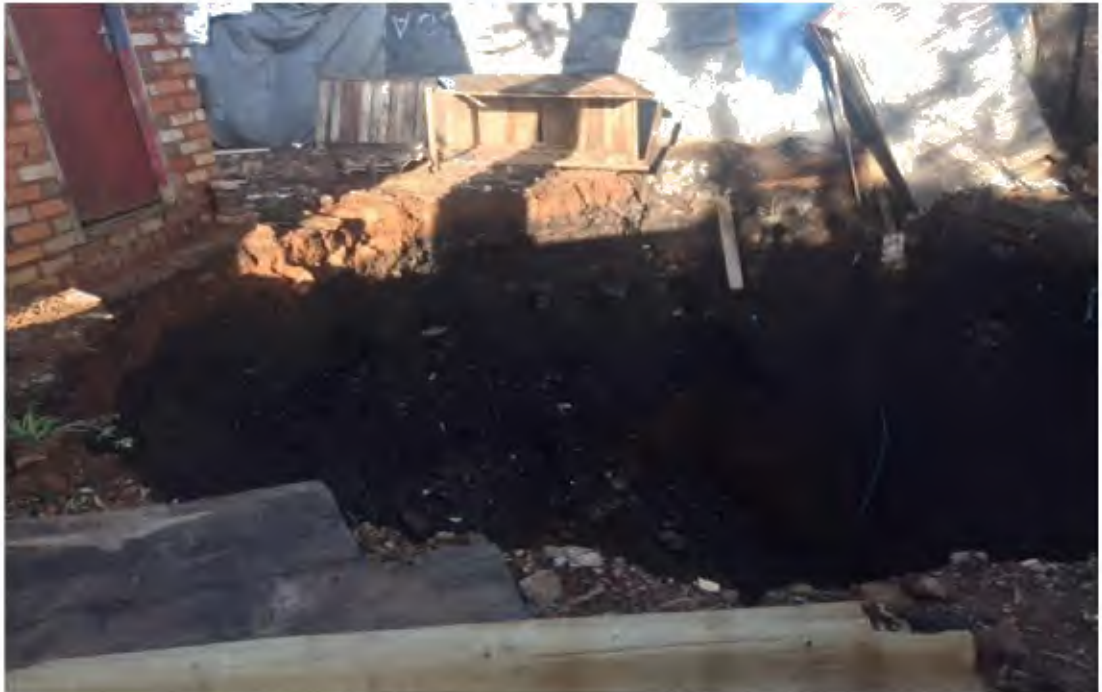
- A big hole occurred in the middle of the yard very close to the shack.
- The hole is 0 m away from the shack and is approximately 7m wide and approximately 5m deep.
- No municipality wet services running along where the sinkhole occurred was observed.
- No current leaking of EMM wet services were observed during investigation.

From the investigations done, the area is an informal settlement and there are no municipal wet services running through where the sinkhole occurred. The hole could be due to old mine shafts below the ground. The sinkhole was barricaded.

- The area is non-dolomitic and it was previously used as mine shaft, therefore the DMRS cannot react on this matter.
- The municipal's Human Settlement department should vacate the residents as the area is unsafe.
- It is recommended that the Department of Mineral Resources and/or Council of Geoscience explore the extent of the hole and backfill if possible.
- If possible the Department of Mineral resources should investigate the old shafts around the area if they were rehabilitated properly and advise accordingly.

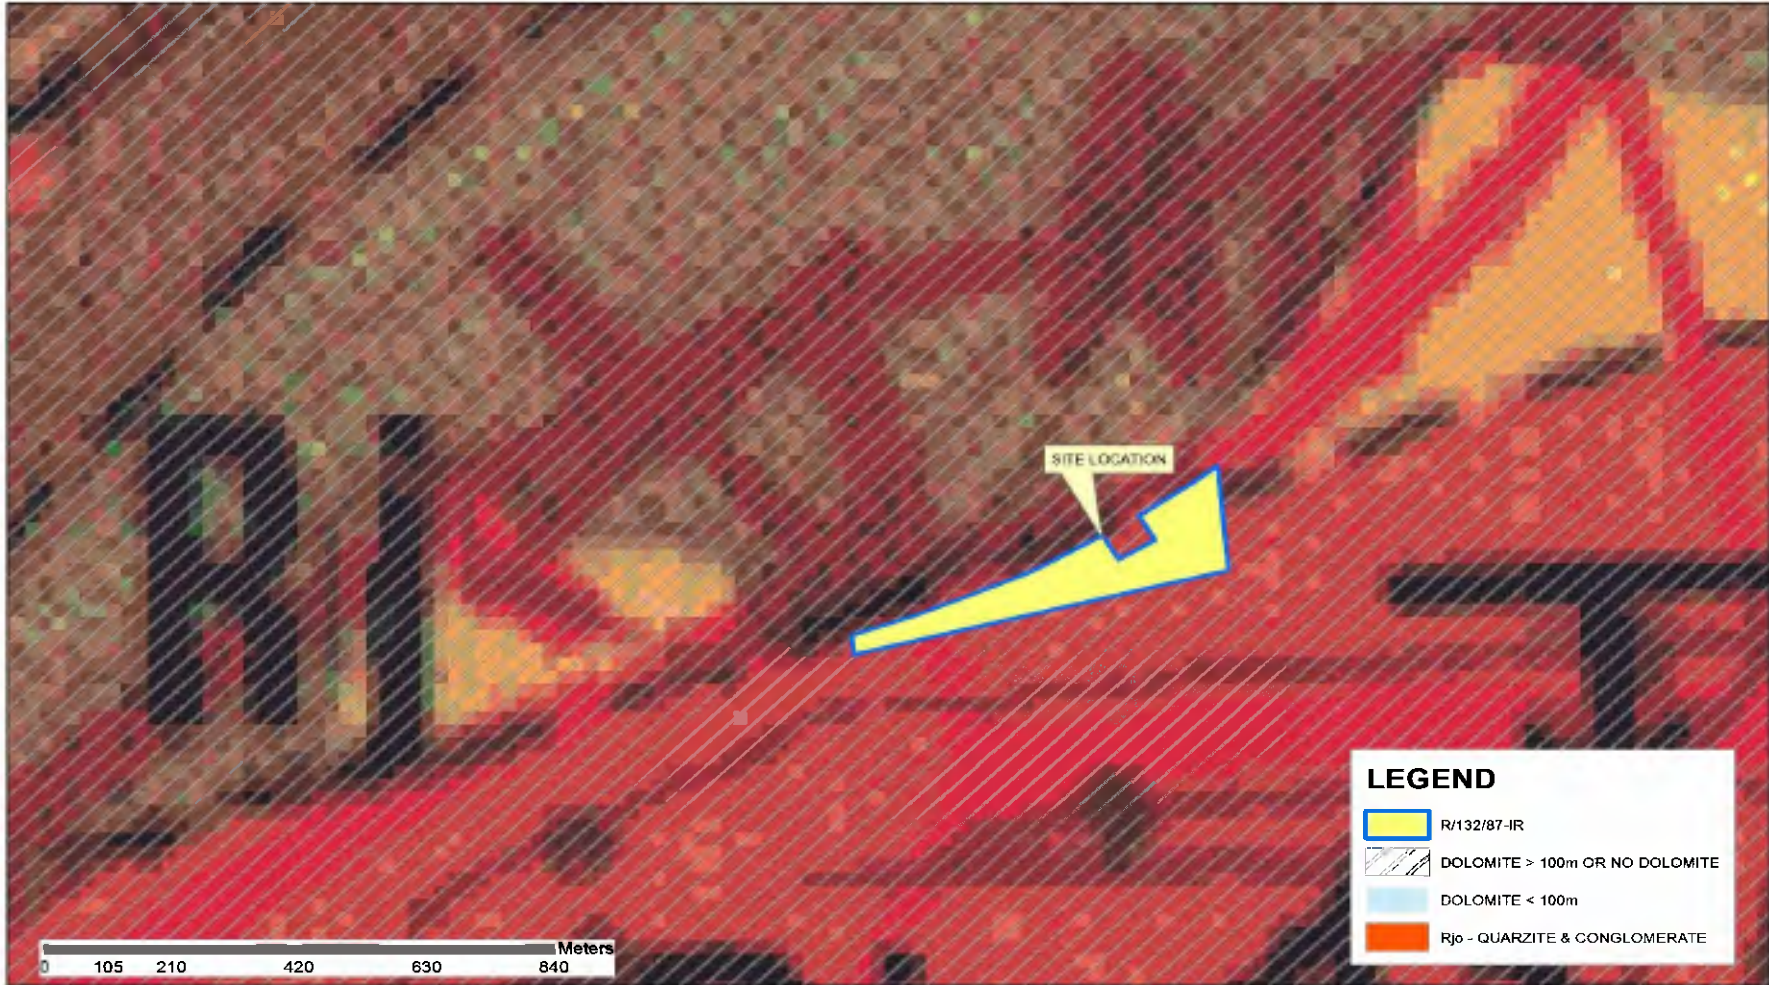
FIGURE 2: GEOLOGY MAP
(REF. MAP: 2628 EAST RAND GEOLOGICAL SERIES 1:250 000)

The available geological information 1:250 000 geological map (2628 EAST RAND) indicates that the stand is underlain by quartzite and conglomerate of the Johannesburg Subgroup of the Central Rand Group of the Witwatersrand Supergroup (Non-dolomitic) (Fig 2).
