**Council for Geoscience
Applied Geoscience Solutions**

CGS Reference: Makause Informal Settlement
Enquiries: NJ Nxumalo
Tel: (012) 841 1173/2
Email: njnxumalo@geoscience.org.za
No. of Pages: 7

23 November 2016

SINKHOLE INSPECTION LETTER REPORT AND RECOMMENDATIONS

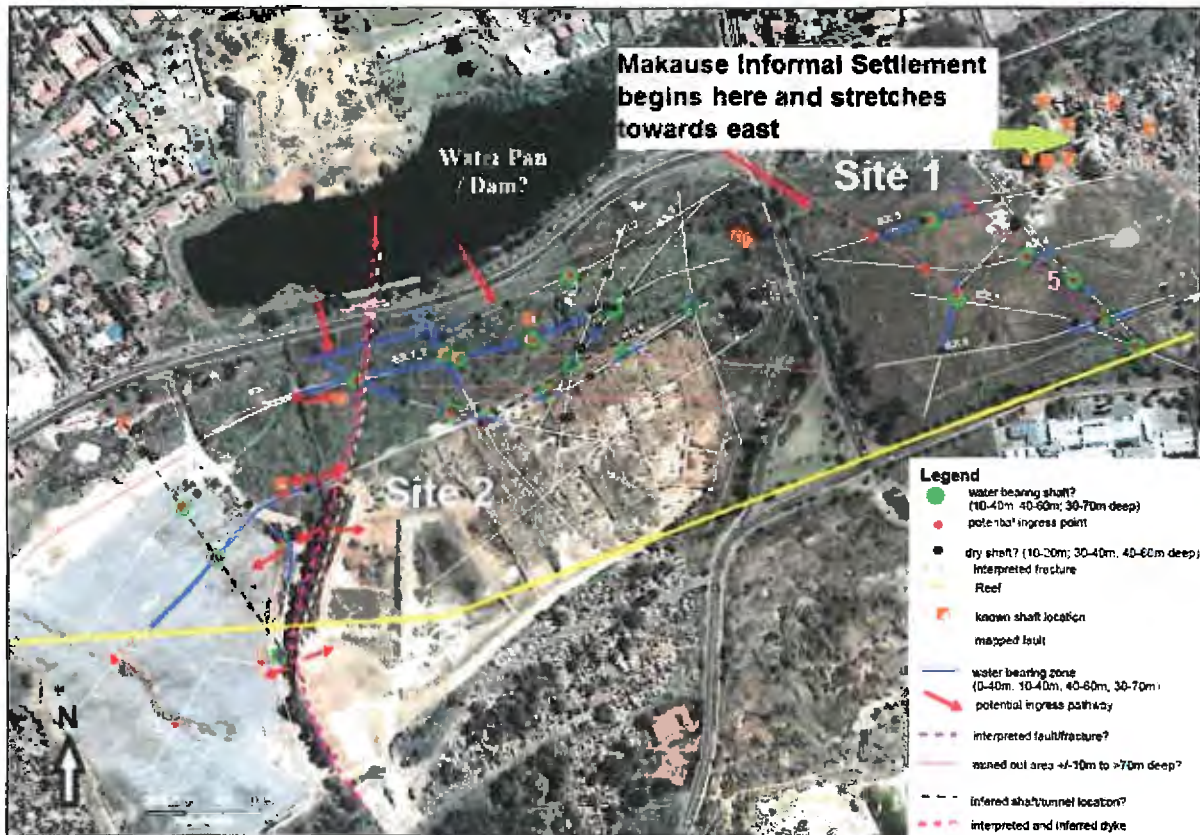
Figure 2: Known Mine Shaft location in close proximity of the site (Adapted from Diop and Chirenje, 2010).

During previous studies by CGS, a geophysical method (Resistivity) and percussion drilling was conducted on the site. During this exercise, nine (9) percussion boreholes were drilled on the south western portion the site (site 1 & 2 on figure 2). Eight out of the nine boreholes encountered a horizon of various fill material overlying weathered shale or quartzite at depths ranging from 2 m to 7 m below surface. The fill material ranged from loose mine waste sand to domestic refuse and building rubble. However, no fill was observed in the borehole PRIM 05, which was drilled directly into highly to moderately weathered quartzite.

Although voids were only intersected in borehole PRIM 03, the loss of air and rapid penetration of the drill rods in PRIM 06, PRIM 07 and PRIM 08 suggest the distinct probability that stopes in these areas were backfilled with material that has loosen up with time.

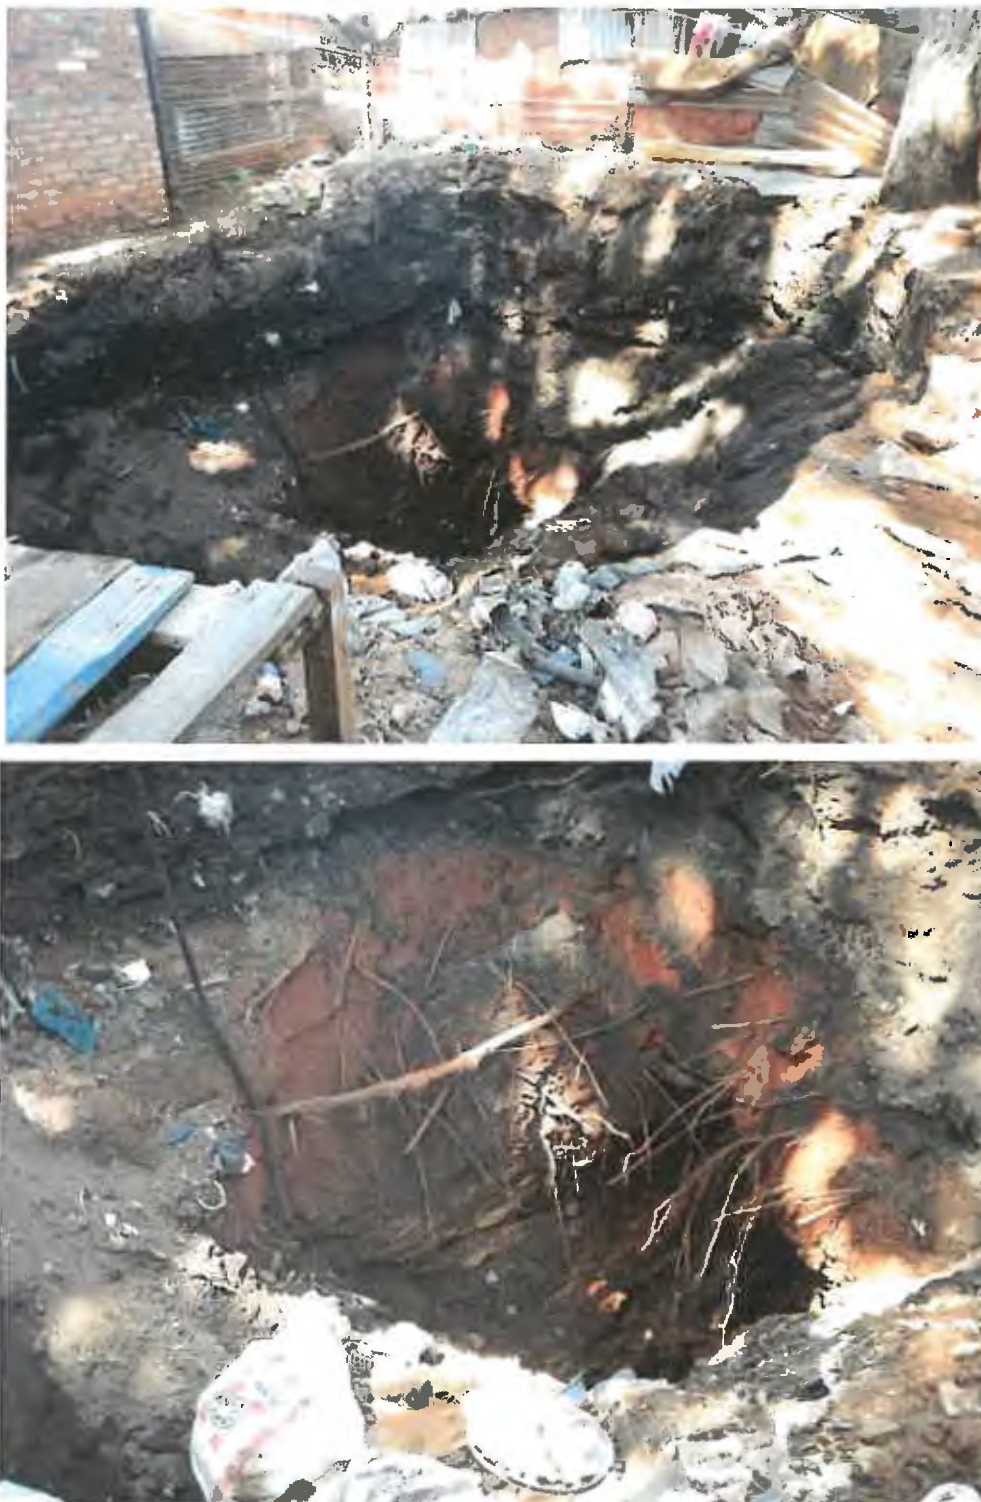
During sinkhole inspections, it was noted that the top soil horizon is characterized by collapsible soils which had progressively collapsed into an old underground/near surface mine hole. The sinkhole is approximately 10 m x 6 m wide and 7 m deep (Figure 3). Fortunately enough, the structures in close proximity of the sinkhole were not affected. No injury or loss of life was recorded in the incident.

Figure 4: Sinkhole between the shacks in Makause Informal Settlement.

The soils above the underground hole comprised of dark brownish black “loose, unconsolidated” fill material of about 2.5 m underlain by orange brown sandy silty clay believed to be highly weathered shale residuum (approximately 1.8 m), which in turn is underlain by what appeared to be light orange brown, highly weathered quartzite of the

Witwatersrand Supergroup. The stability of the soils above the underground hole/opening appeared to have been affected by the introduction of water due to heavy rainfall. It is therefore assumed that the sinkhole was triggered by water ingress. This was deduced from field observations as only the uncovered part (area with not structures on it) of the area was affected. In close proximity of the sinkhole is the previous sinkhole which has been filled up with rubble materials. Land subsidence was also noted closer to one of the shack about 20 m south-east of the sinkhole.

It is therefore recommended that people living in this informal settlement are relocated as an immediate response.

However, the site may be considered for waste disposal in accordance with SANS 10234.
